# SEPTIC INSPECTION

## Septic Tank and Lateral Field:

# Septic Report

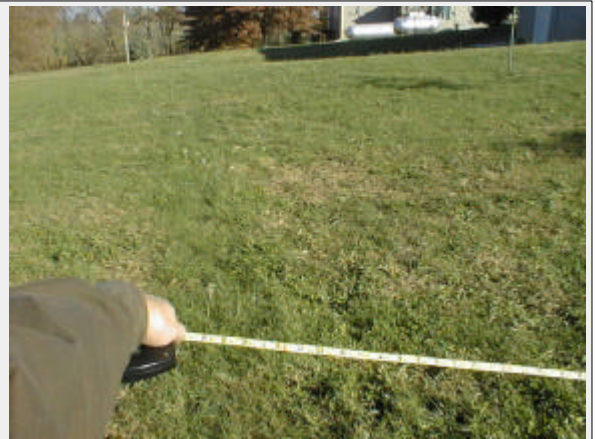
The lateral field appears to be less than the required 100 foot minimum setback from a private water well as required by the State Guidelines. The actual measurement is 74'.

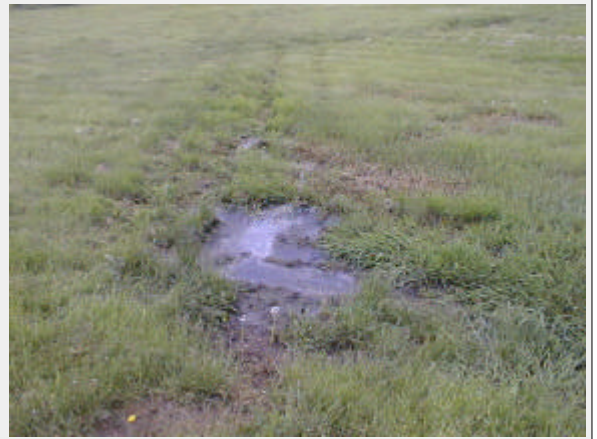
**Action Necessary** - Effluents were noted at the surface in some area of the lateral field. See drawing for affected areas. Surfacing effluent can be differentiated from surface drainage by the offensive odor of sewage (hydrogen sulfide), its black or grayish color and possible lush growth of vegetation.

**On the date noted above, a review of the on-site sewage system indicated that the system does not appear to be functioning in a satisfactory manner. Services of a licensed professional are needed to effect the needed repairs.**
